**CALSPAN ON-SITE AIR BAG DEPLOYMENT INVESTIGATION**

**CALSPAN CASE NO. 91-3**

**VEHICLE - 1990 GEO STORM GSi  
LOCATION [REDACTED], LOUISIANA  
ACCIDENT DATE - [REDACTED] 1990**

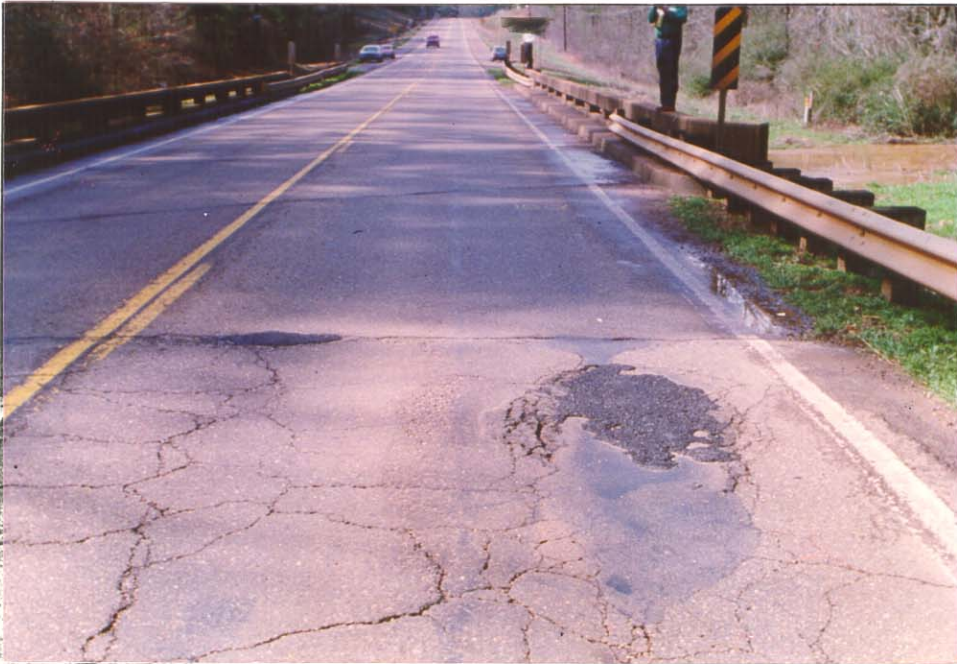
Pre-Crash Trajectory of the Geo Storm GSi

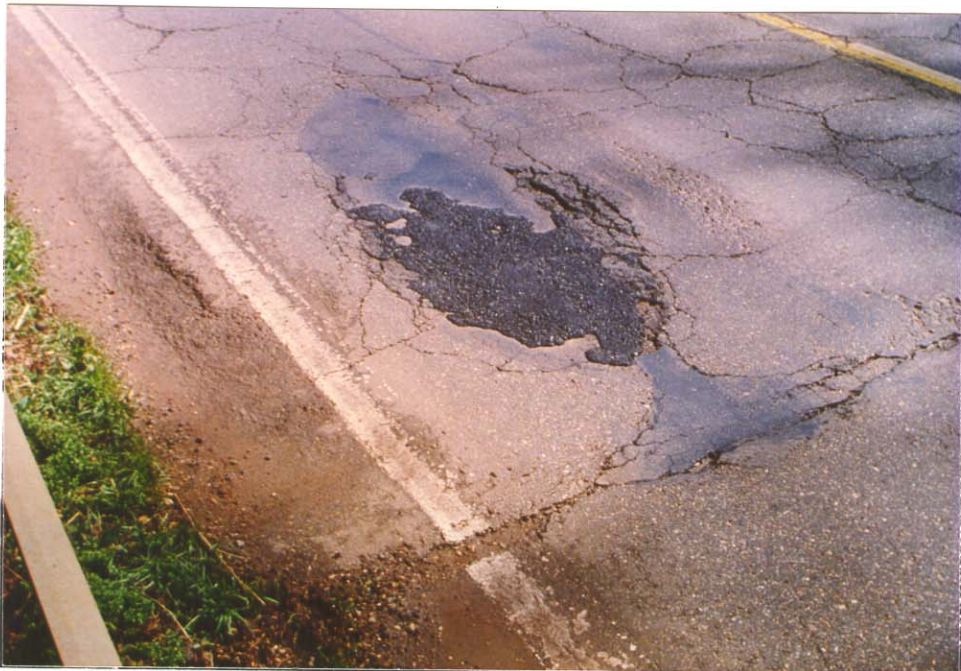
Pavement Depression

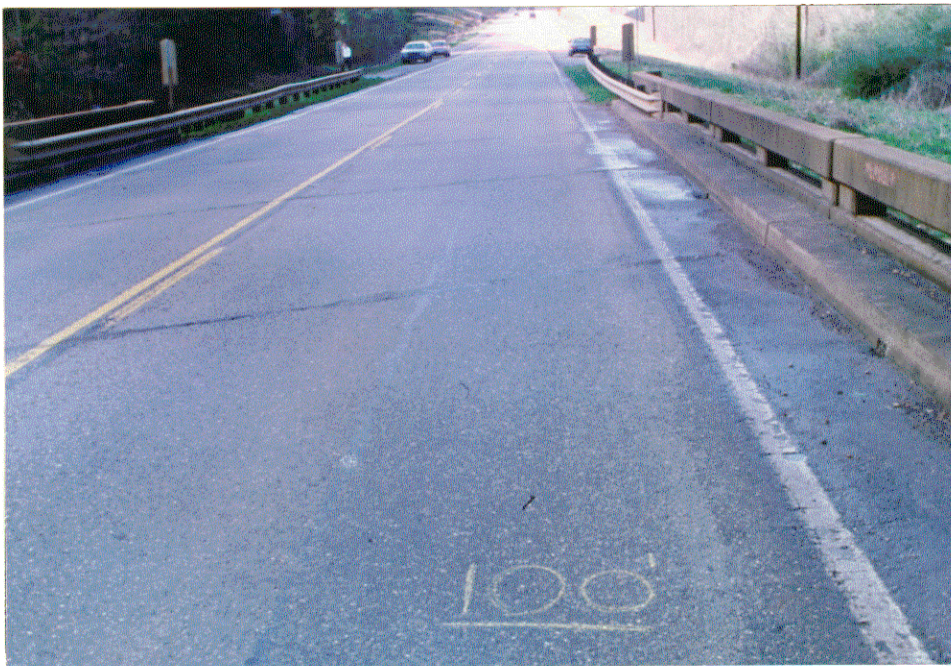
Barrier Curb Struck by Right Rear Tire and Wheel

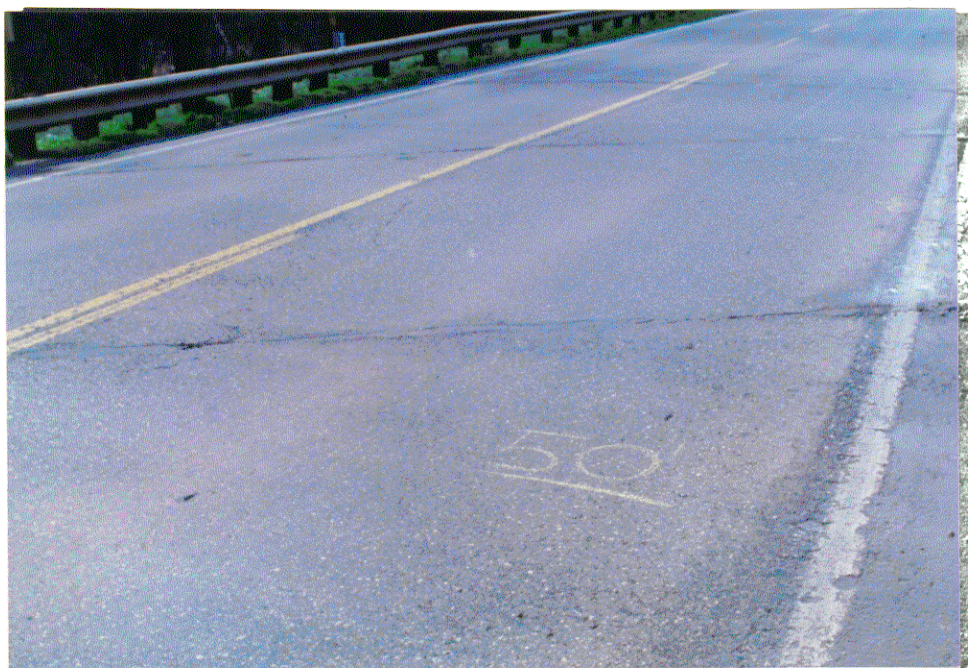
CCW Rotational Trajectory of Vehicle Across Roadway

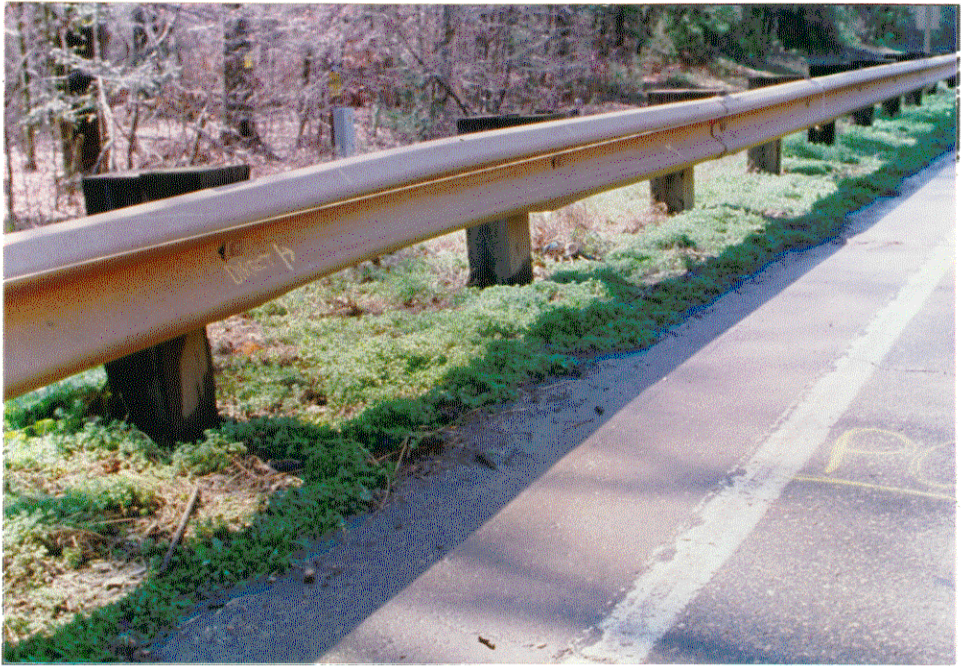
Struck Guardrail

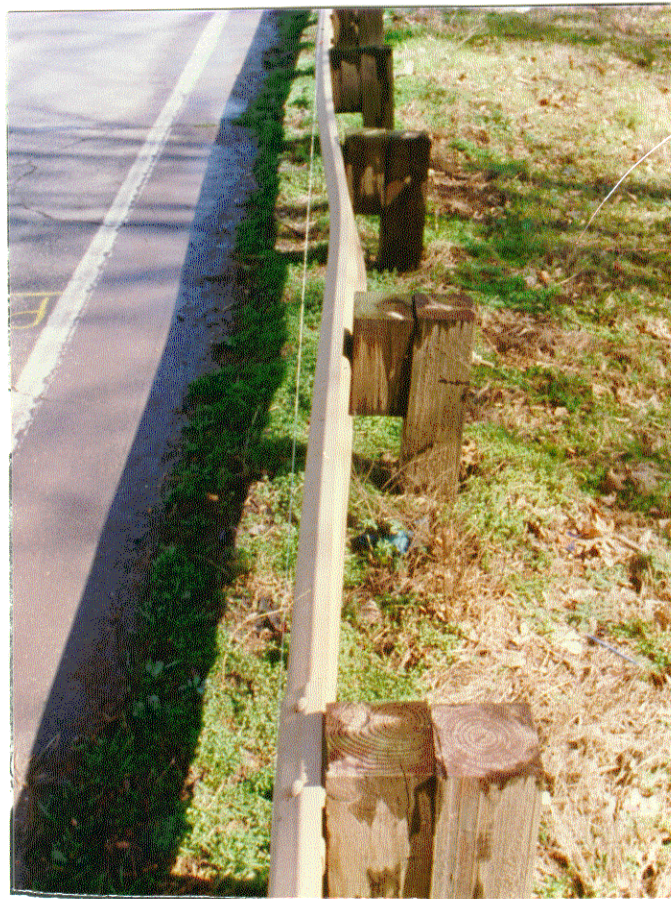
Longitudinal View Showing Deflection to W-Beam Guardrail

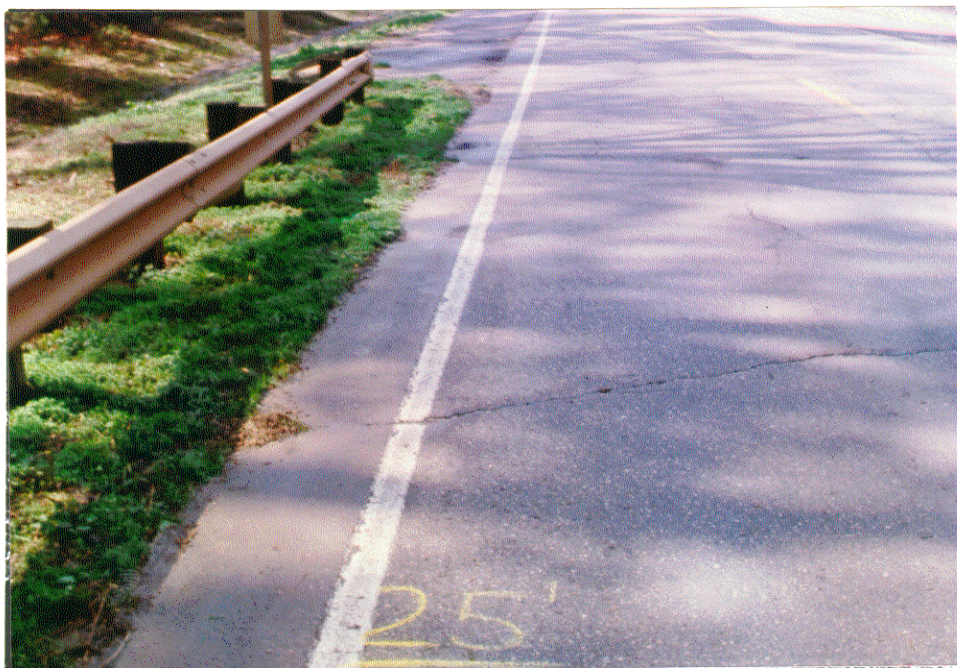
Post-Crash Trajectory of Vehicle

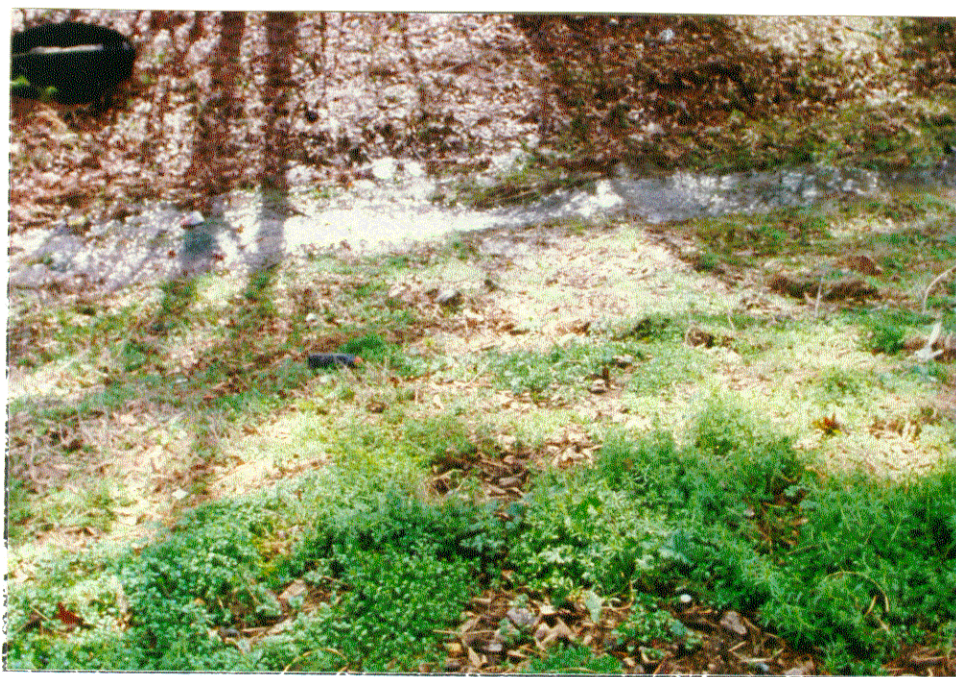
Final Rest Position of the Vehicle

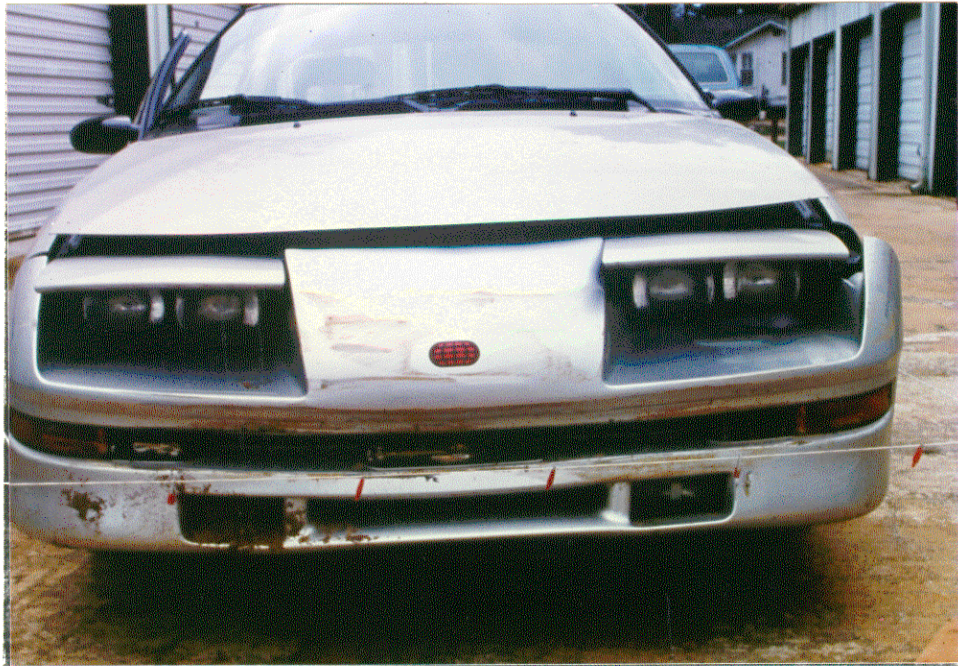
Frontal View of the Geo Storm

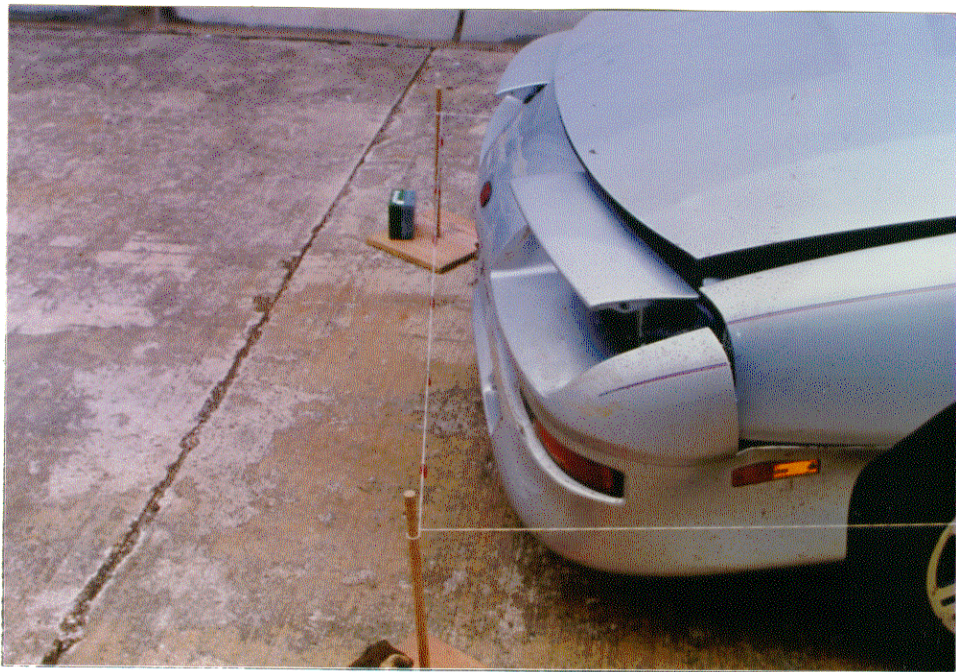
Perpendicular View Showing the Extent of Crush

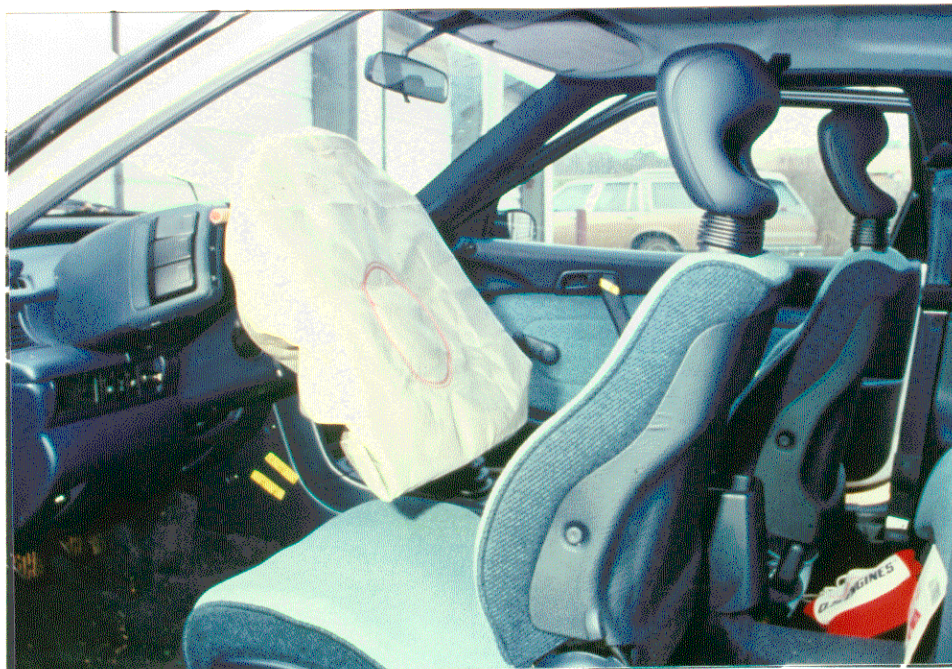
Overall Interior View

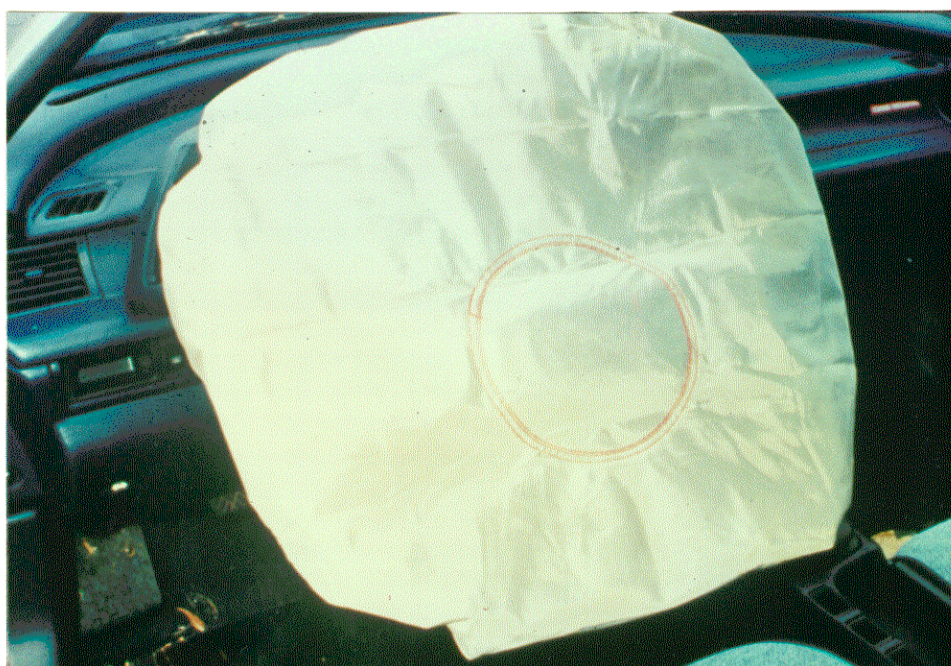
Deployed Driver Air Bag

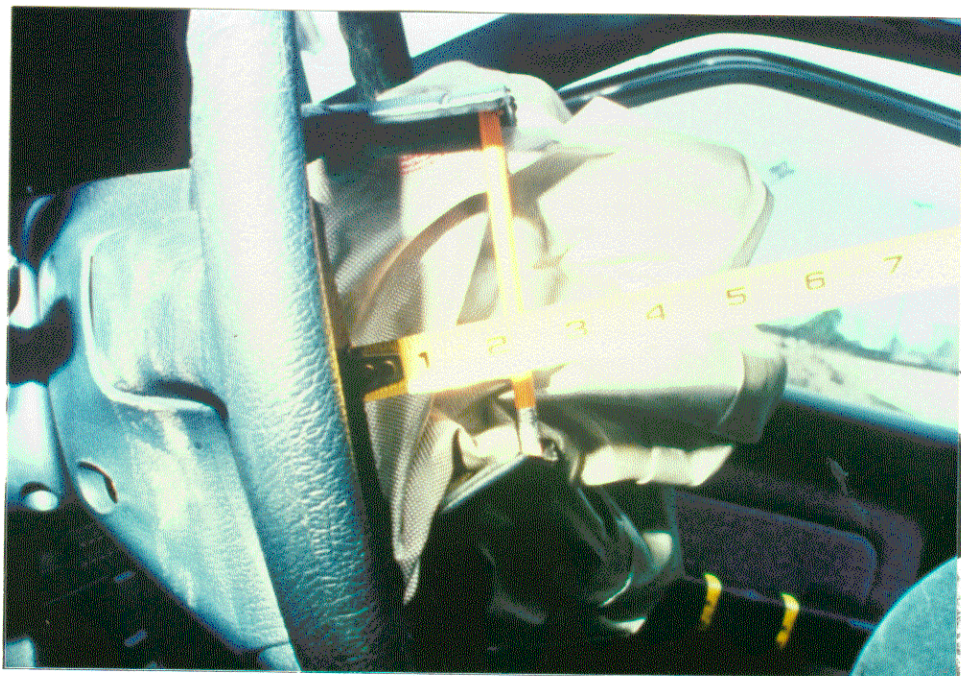
Make-up Transfers on the Peripheral Surface of the Bag

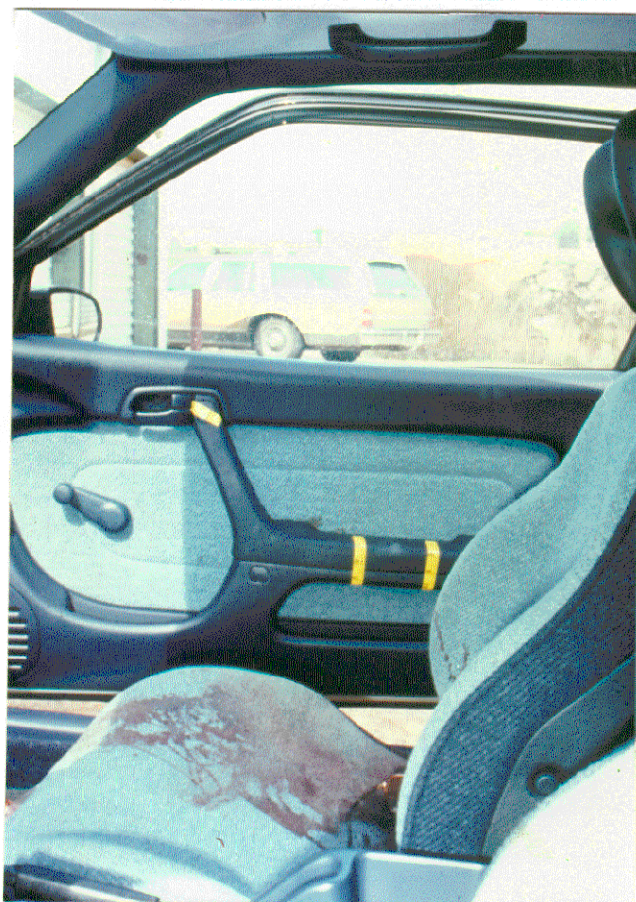
Perpendicular View of the Air Bag Module Cover Flaps

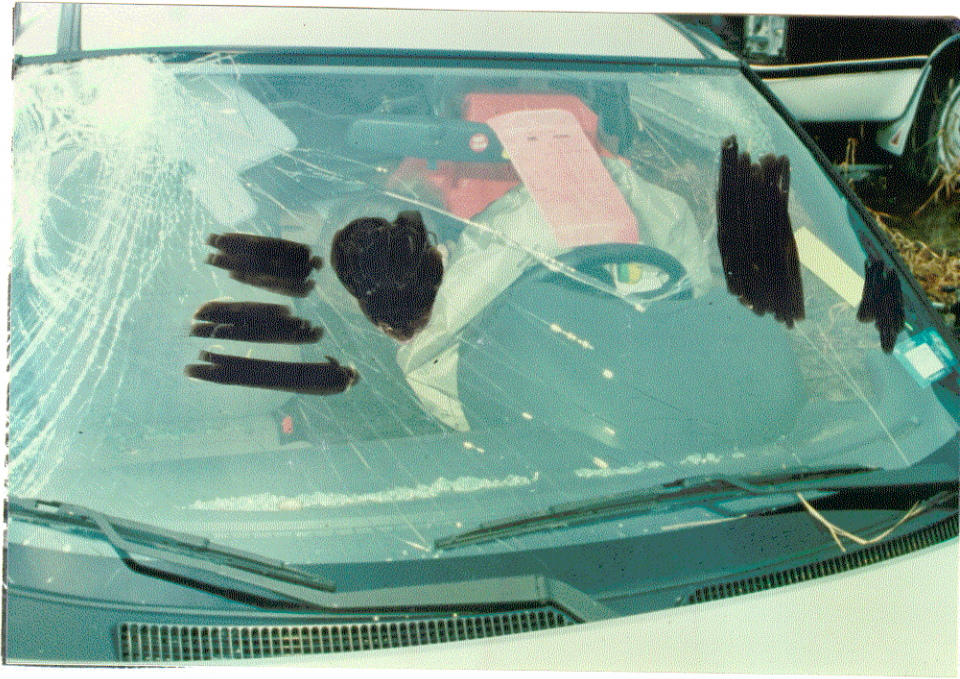
Simulation of Driver Position

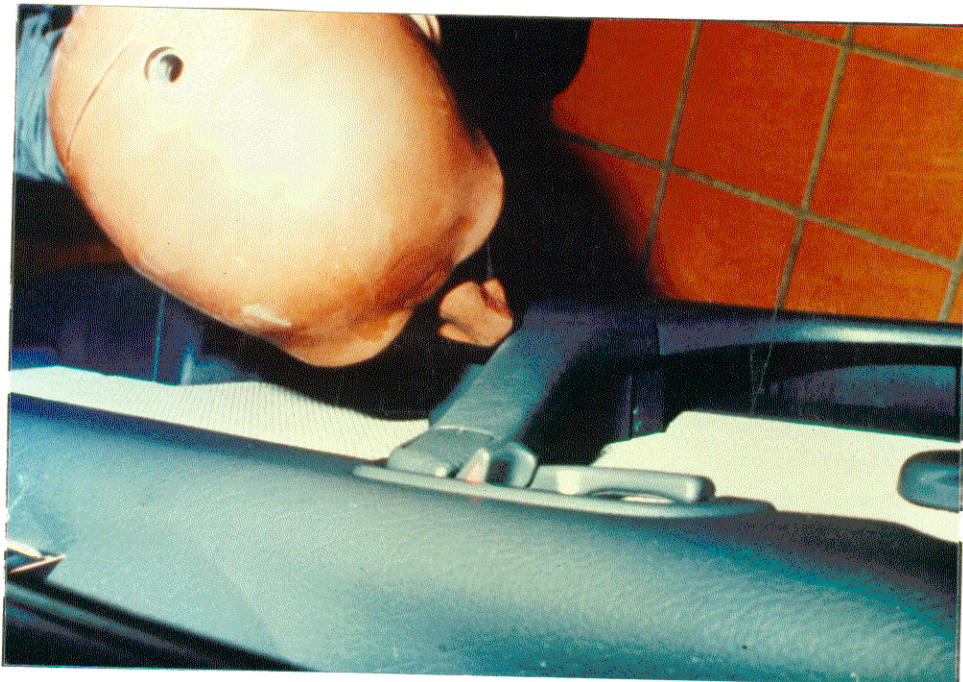
Facial Contact With Deployed Air Bag

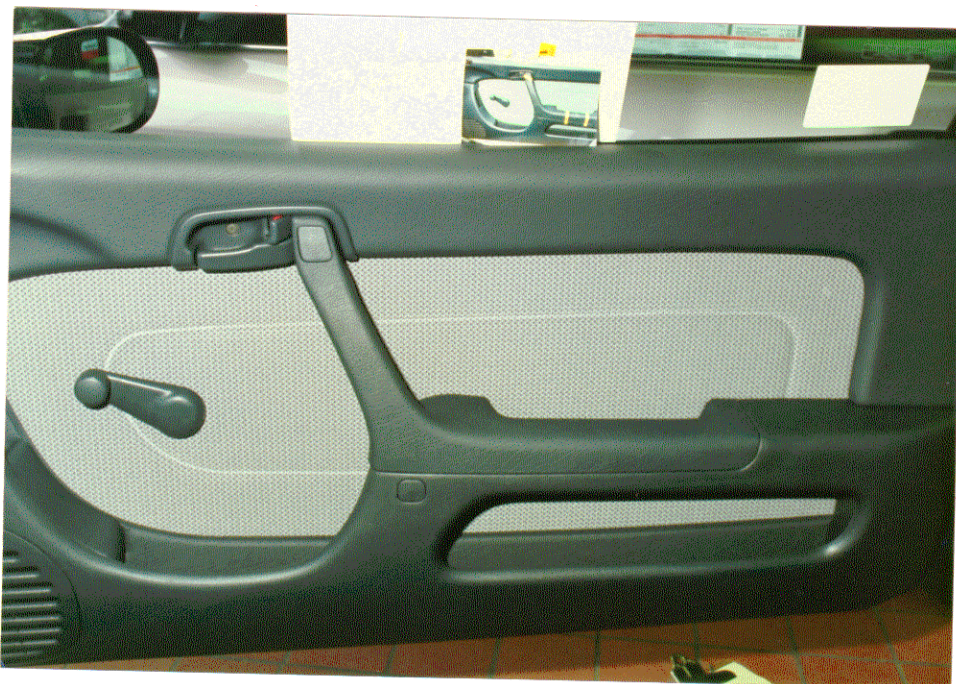
Hybrid III Head Form Simulated Contact With Right Door Pull Handle
